Vibration Sensor

VS Series: VS-1 VS-1^R VS-2^{SI}

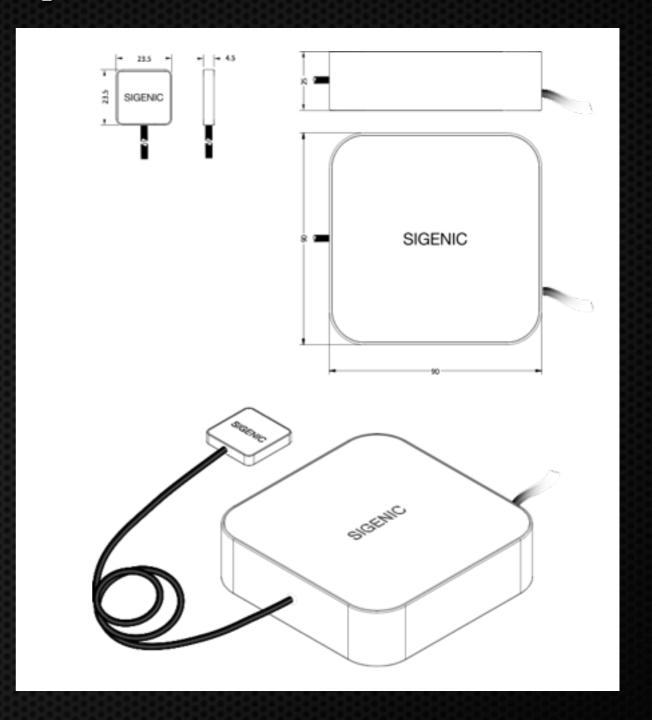
VS-1 Sensor Specification

Measurement of Acceleration	3 Directions (i.e. X, Y, Z)
Measurement Range	+ / -2g, 4g, 8g, 16g
Non-Linearity	0.5%
Sensitivity Change Due to Temperature	0.01% per 1 degree celsius
Resolution	0.01g
Output Data Rate	0.1 to 3200Hz
Operating Temperature	-20 to 80 degree celsius
Shock Resistance	10000g

- Compact design with user-friendly interface
- Generates a high output data rate
- Simple and convenient plug-n-read USB operation
- Supplied in sturdy lightweight carry cases for portability

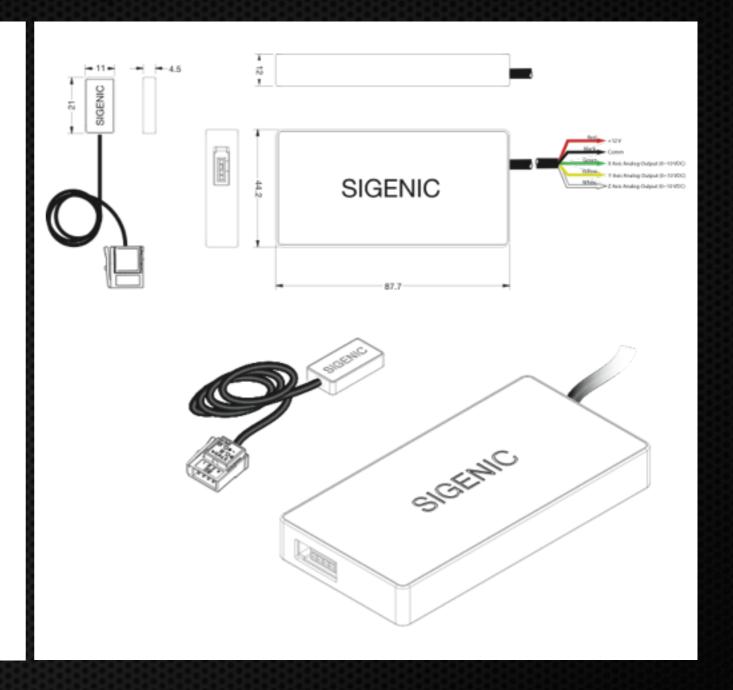
VS-1^R Sensor Specification

Measurement of Acceleration	3 Directions (i.e. X, Y, Z)
Measurement Range	+ / -2g, 4g, 8g, 16g
Non-Linearity	0.5%
Sensitivity Change Due to Temperature	0.02% per 1 degree celsius
Output Data Rate	200Hz / 1000Hz
Operating Temperature	-20 to 80 degree celsius
Shock Resistance	10000g
Analog Output (X, Y, Z)	0 ~ 10 VDC

- Slim, light weight design allowing great ease during installation on machines
- Real time monitoring capability of machine health condition

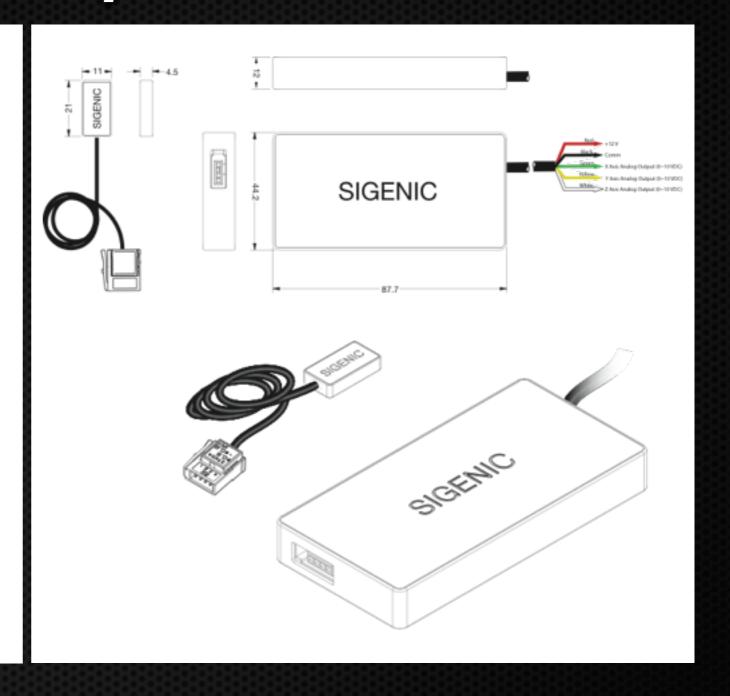
VS-2^{SI} Sensor Specification

- Slim and light weight
- Real time monitoring capability
- Vibration Stability Index, capturing the overall stability of a complete work cycle

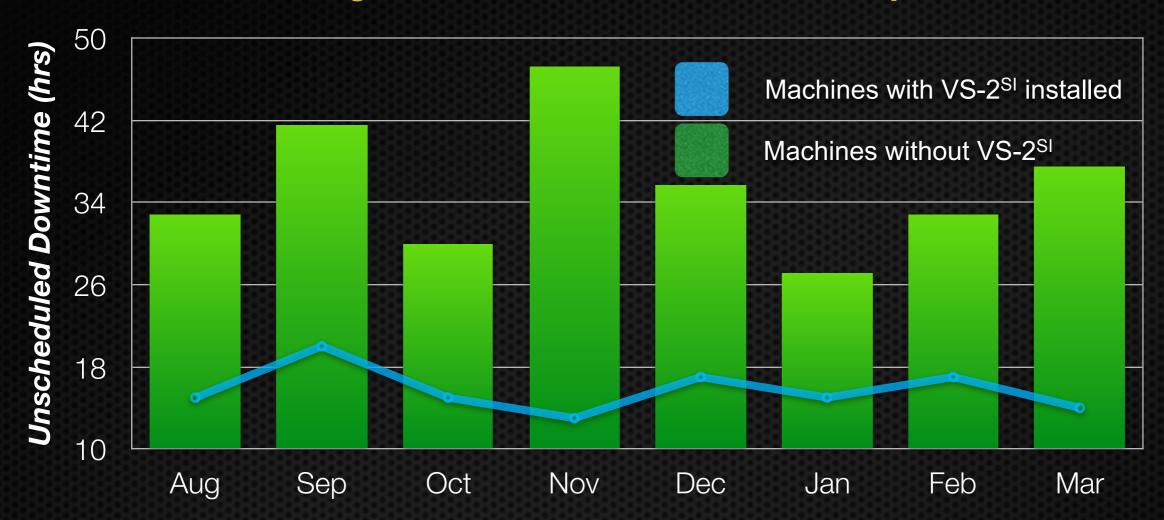
Average Unscheduled DownTime Comparision

Reduced UDT translates into:

- Lesser Manpower Costs in fault finding
- Higher Yield Rates
- Higher Profit Margin

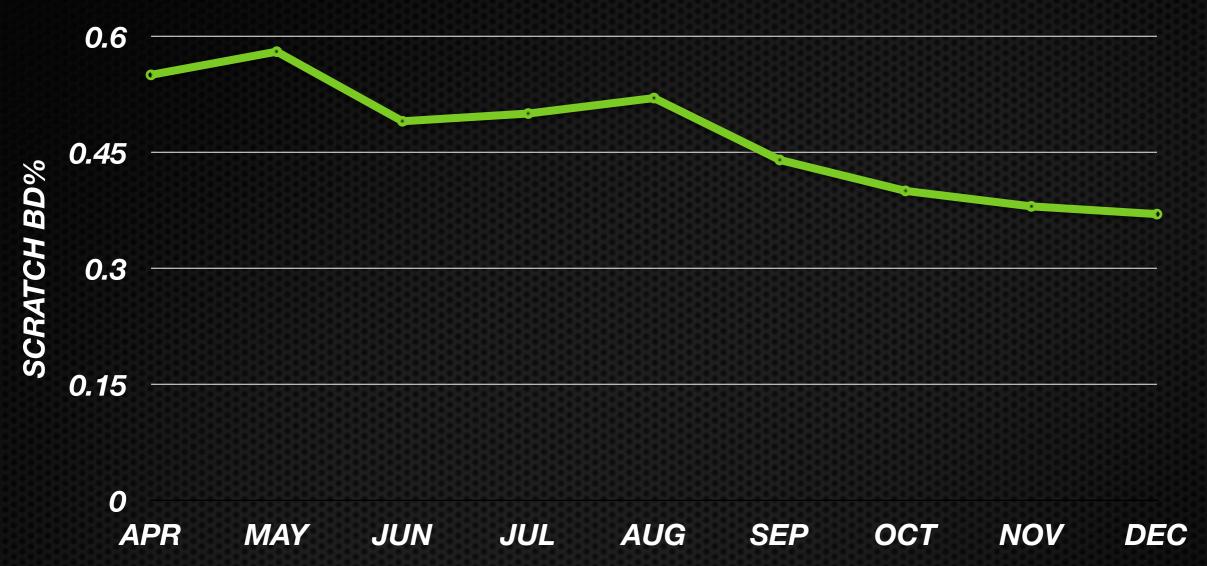
Micro Scratches Bad Die % (FEOL CMP STI/ILD)

- Micro-Scratch BD% improves by 0.131%.(From 0.528% to 0.397%)
- Fab Line Yield improved by 0.131%
- Translates into monthly cost saving of USD 230K from micro-scratches baseline improvement for a 50,000 output wafer fab

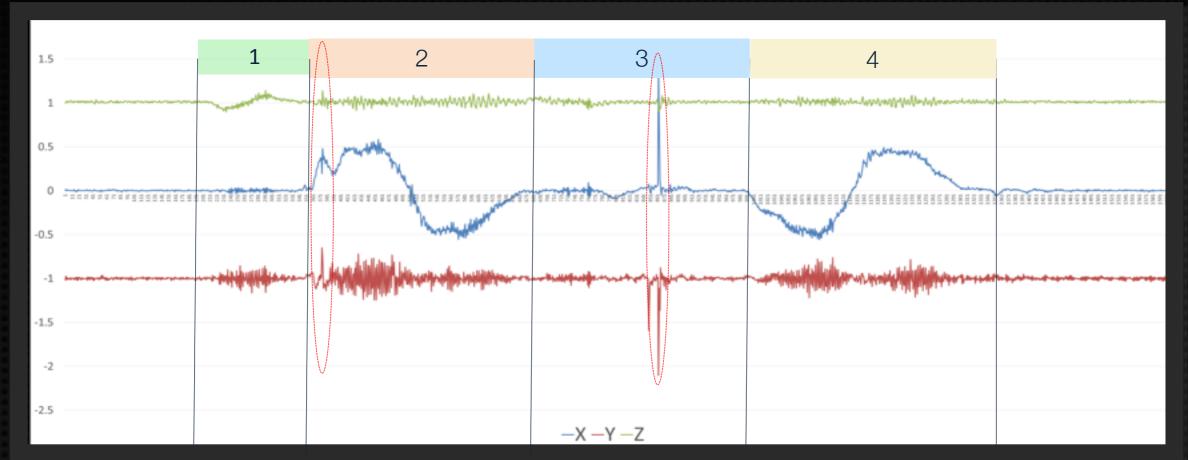
FI Robot Wafer Retrieval Motion

Data logged by VS-1:

Four main steps of the retrieval motion:

- 1. Fl robot to ready position (pick up slot position) (Z-axis motion)
- 2. Robot blade extend into FOUP (X-axis motion. Plunger will retract during start of this step)
- 3. Robot blade pick up wafer (Z-axis motion, wafer lifted up from slot and plunger extend to hold the wafer)
- 4. Robot blade retract from FOUP (X-axis motion, wafer retrieval action completed)

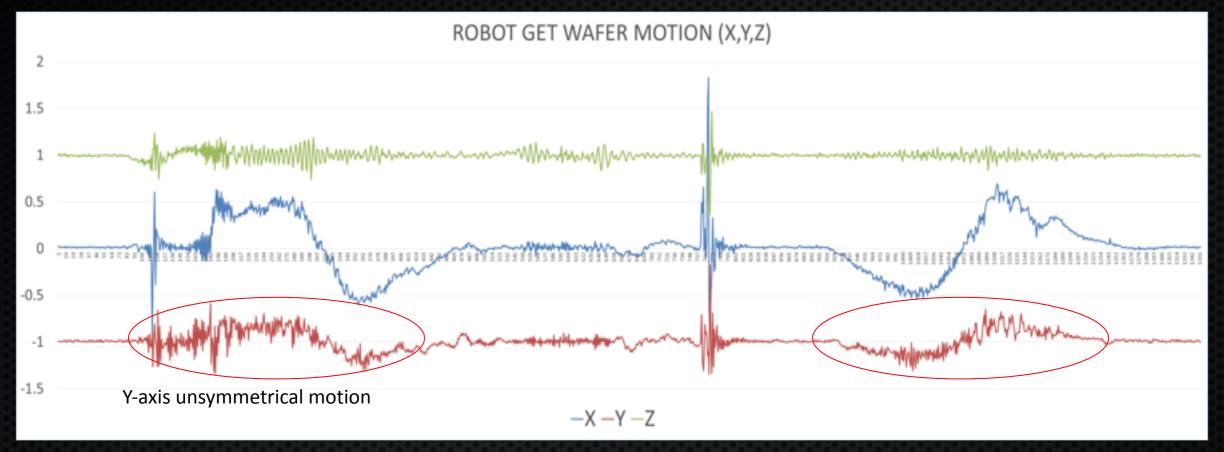
VS-1 SubCase Study 1:

Y-axis unsymmetrical motion captured during wafer retrieval action

Observation:

Y-axis unsymmetrical motion

Risk:

Wafer may rubbing against transfer station (FOUP or pathway)

Possible Root Cause:

Robot arm bearing loosen

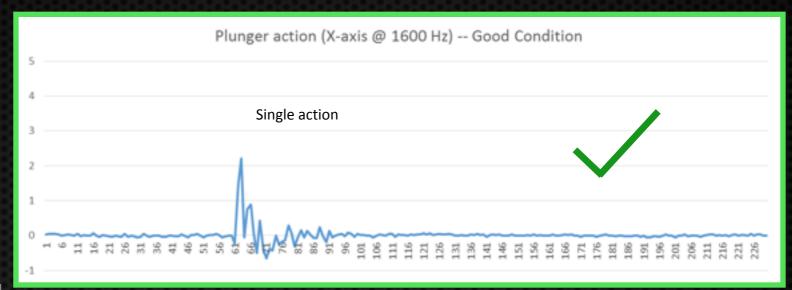
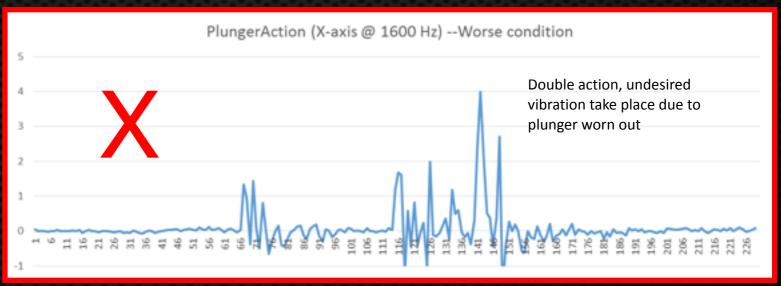
Worn out plunger induce double action during holding a wafer

- 1. Robot plunger hold/ grip wafer during wafer transfer
- 2. Plunger force applied directly to the wafer edge (too high will cause wafer to break, too low might cause wafer drop during supinator)
- 3. Vibration behaviour during wafer gripping process can use to monitor plunger and robot fang condition

Worn out plunger induce double actions during holding a wafer

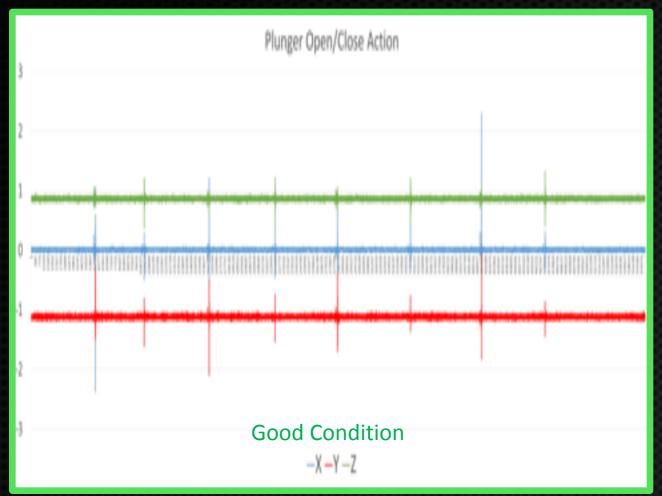
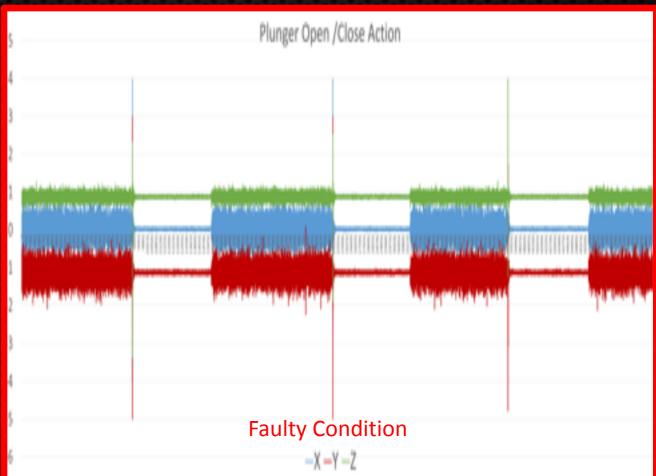
VS-1 SubCase study 3:

Plunger actuator's fitting broken cause abnormal vibration during wafer gripping

Observation:

Abnormal vibration detected when plunger was gripping a wafer

Root Cause:

Plunger actuator's fitting broken

Replace actuator fitting. Vibration behaviour back to normal

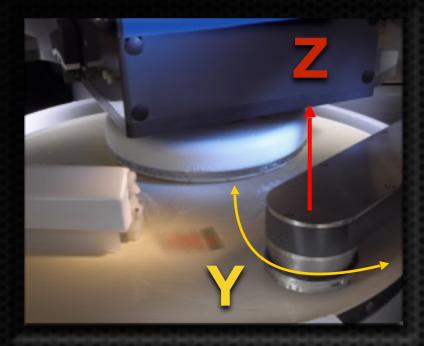
Pad Conditioner (PC) Arm Vibration Behaviour

Data logged by VS-1 @ 800Hz:

The **VS-1** was deployed to detect the vibration of the PC Arm. The yellow arrow Y indicates the sweeping movement of the PC Arm

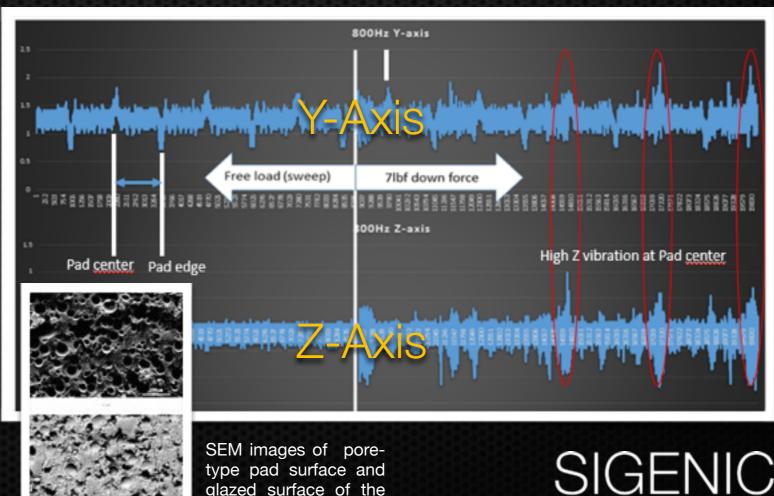
Logged data showed Z-axis vibration to be high at the centre of the pad. Follow-up investigation found that the High Pressure Rinse DIW nozzle spray was weak at pad centre area (insufficient water) and increased the friction.

This will result in low cleaning efficiency at pad centre area and induce pad glazing and micro-scratch issues.

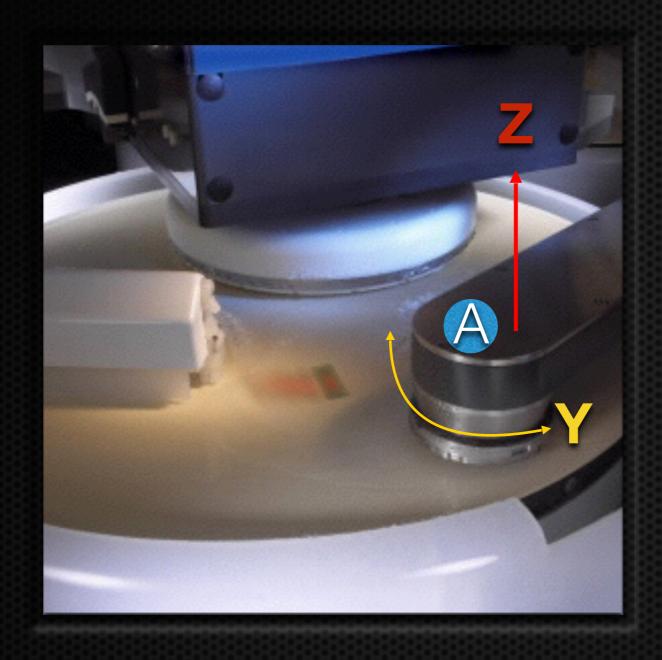
VS-1^R Real Time Detection:

- VS-1^R was installed at PC Arm head, indicated A.
- The Z axis, which to measure the vertical vibration behaviour, as indicated by the red arrow.
- The Y axis, measures the left/ right sweeping movement (horizontal vibration behaviour), as indicated by the yellow arrow.

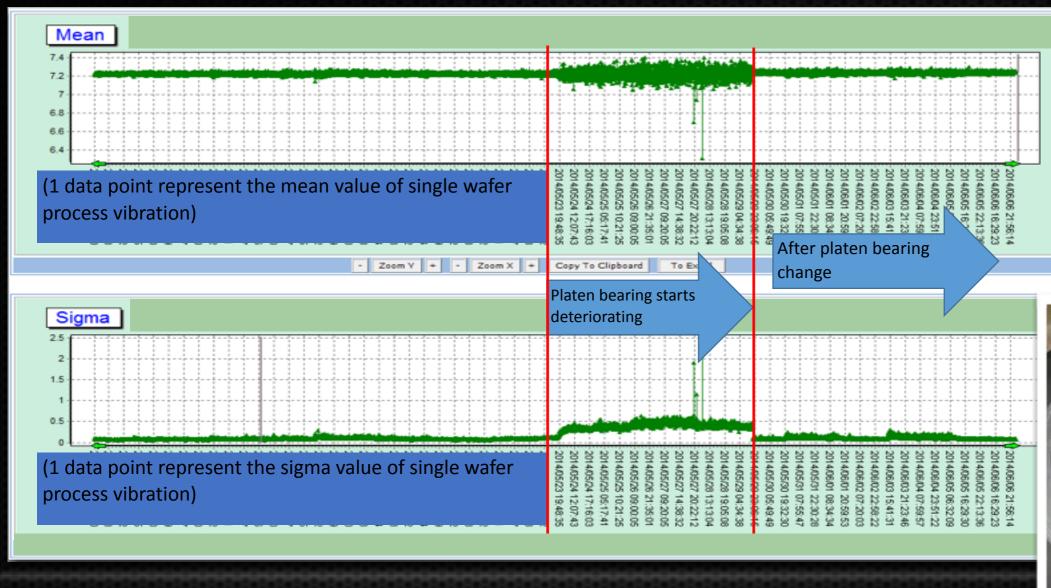
VS-1^R SubCase study 1:

Polisher platen bearing abnormality was detected Motor torque endpoint failure issue was resolved

Z-axis experienced **high working vibration** and unstable wafer polish endpoint (motor torque) **Root cause:**

Platen bearing worn out and caused high vibration on Pad Conditioner Arm Z-axis Corrective Action:

Replaced new platen bearing, vibration level back to normal baseline

Rusty bearings caused the unstable torque, which incurred abnormal vibration

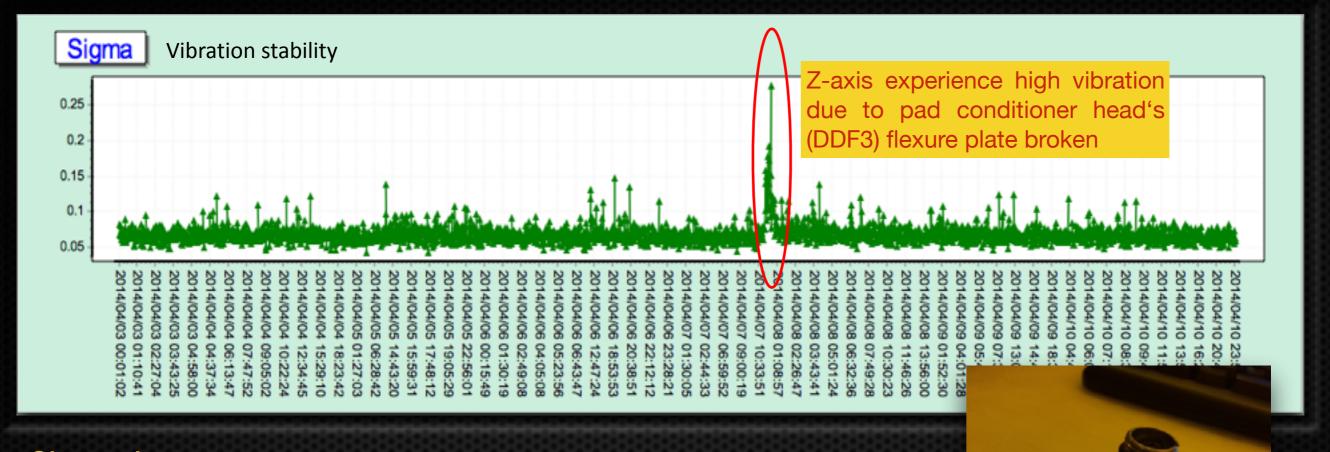
VS-1^R SubCase study 2:

Early detection of broken PC Arm's flexure plate

Observation:

Z-axis vibration sigma abnormal

DDF3 flexure plate broken

Replaced new flexure plate, Z-axis vibration sigma back to normal baseline

Fail to detect this issue may causes pad glazing and result in wafer scrap due over polish and micro-scratch issues.

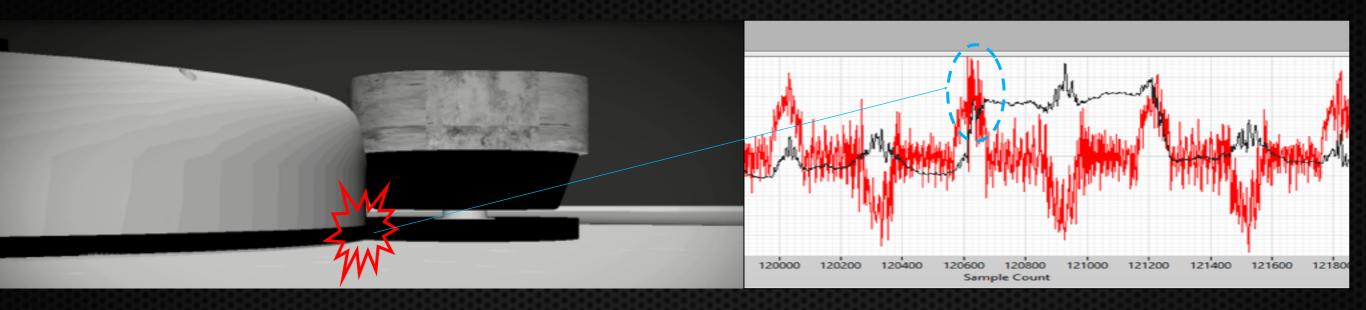
VS-2^{SI} SubCase study 1: STI PC DDF3 Colliding against Polishing Head

Observation:

PC DDF3 colliding against polishing head during process

Suspected root cause:

- PC home position drift
- Faulty PC sweep mechanism cause over-sweeping motion, leading to the collision of PC DDF3 and polishing head.
